NAVAL AVIATION SAFETY CENTER

KC-130F BUNO 149802, assigned to Marine Aerial Refueling/Transport Squadron 152 (VMGR-152) and commanded by Captain (b) (6), 7308, USMC, crashed at 1010 (local) on 24 August 1965 during an attempted take off from Kai Tak Airport, Hong Kong. There was a crew of 6 and 65 passengers were on board. During the take off attempt the aircraft swerved to the left, became airborne momentarily, dropped the left wing which hit a seawall and plunged into Kowloon Bay. Fire enveloped the wreckage as it came to rest in a near submerged condition. There were a total of 12 survivors consisting of 4 crew members and 8 passengers. 57 passengers and 2 crew members sustained fatal injuries from impact, burning and drowning. Damage to private property was negligible.

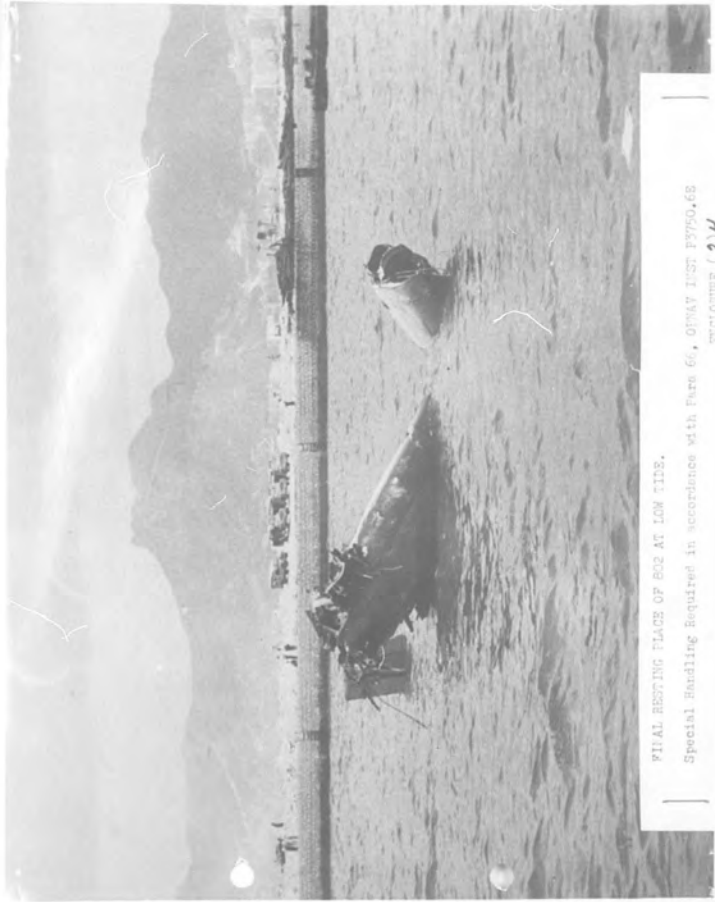
Enclosure (1)

FINAL RESTING PLACE OF BQ2 AT LOW TIDE.

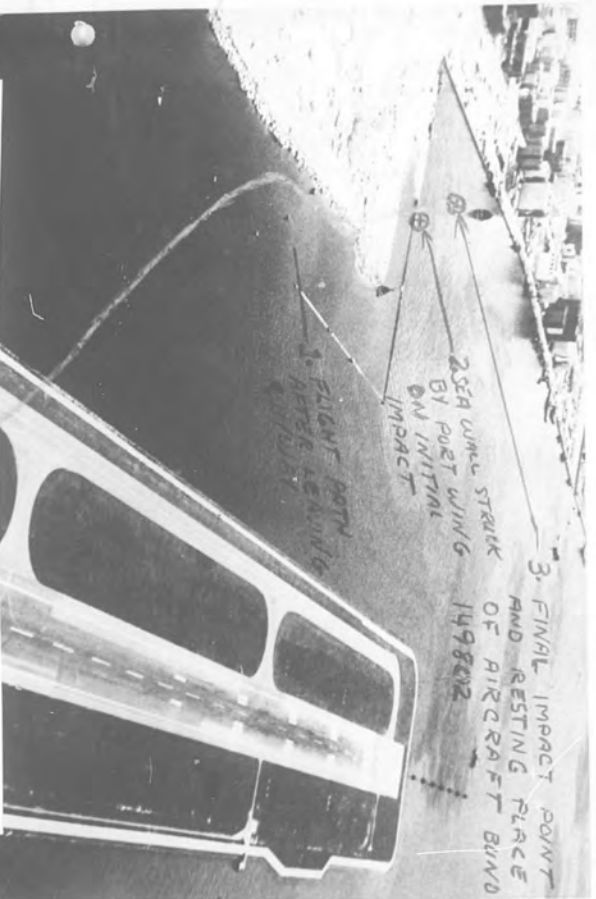
DEICTS FLIGHT PATH OF AIRCRAFT AS CONSTRUCTED FROM STATEMENTS. TIME IN FLIGHT APPROXIMATELY ONE MINUTE.

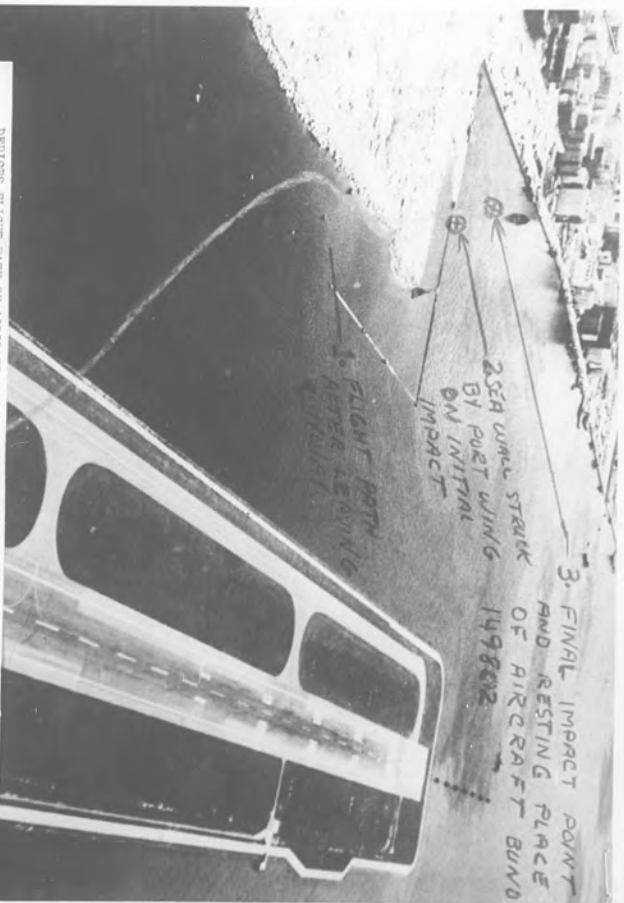
DEPICTS FLIGHT PATH OF AIRCRAFT AS CONSTRUCTED FROM STATEMENTS. TIME IN FLIGHT APPROXIMATELY ONE MINUTE.

SWERVED OFF
RAILWAY AT THIS
POINT (3800 FT)

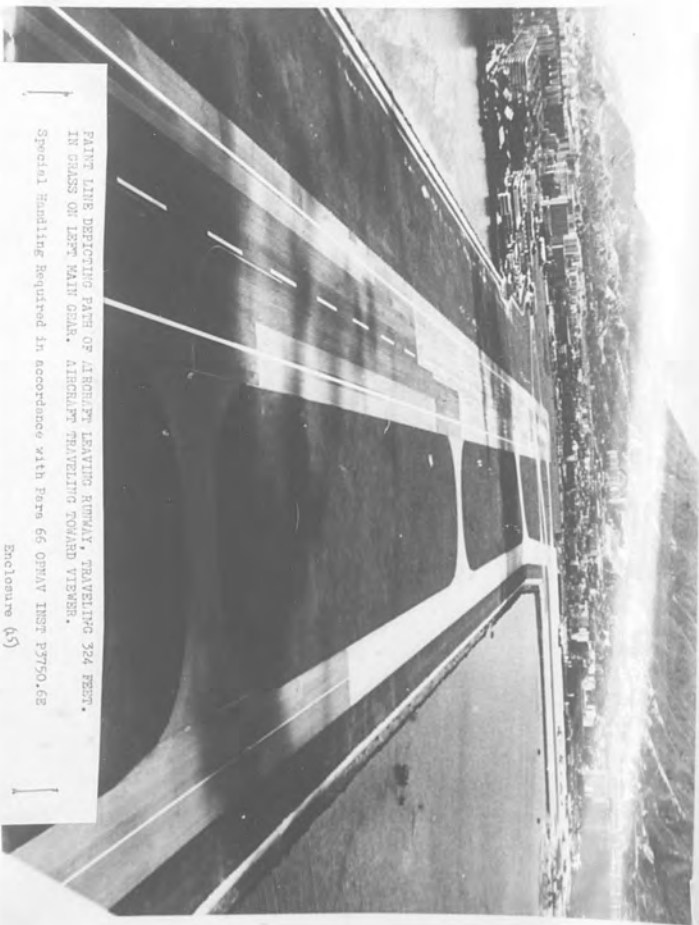
Enclosure (45)

PAINT LINE DEPICTING PATH OF AIRCRAFT LEAVING RAMPWAY, TRAVELING 324 FEET.
IN GRASS ON LEFT PAIR GEAR. AIRCRAFT TRAVELING TOWARD VIEWER.
Special Handling Required in accordance with Para 66 OPNAV INST 3750.62

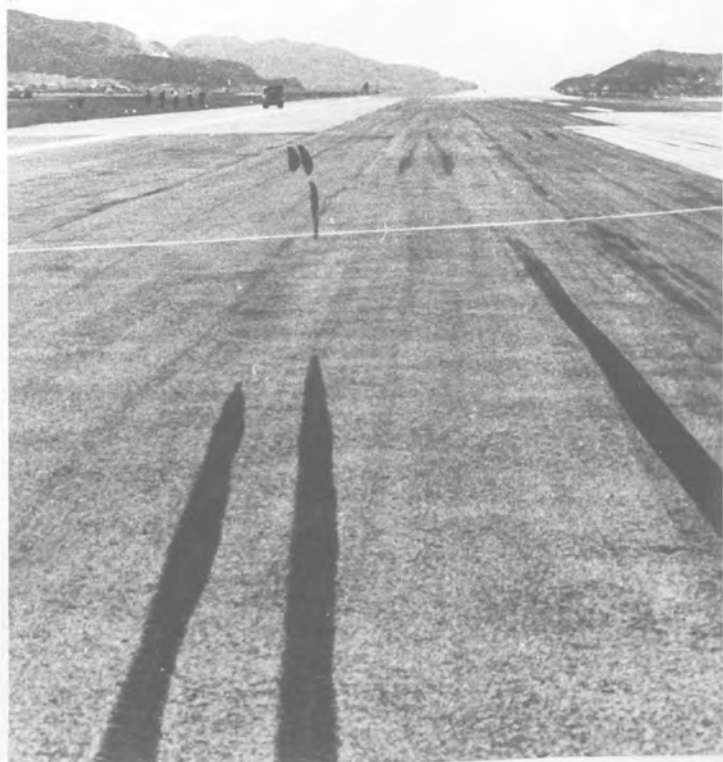
SKID MARKS OF NOSE GEAR DEPICTING EXCESSIVE SKIDDING TO THE LEFT.

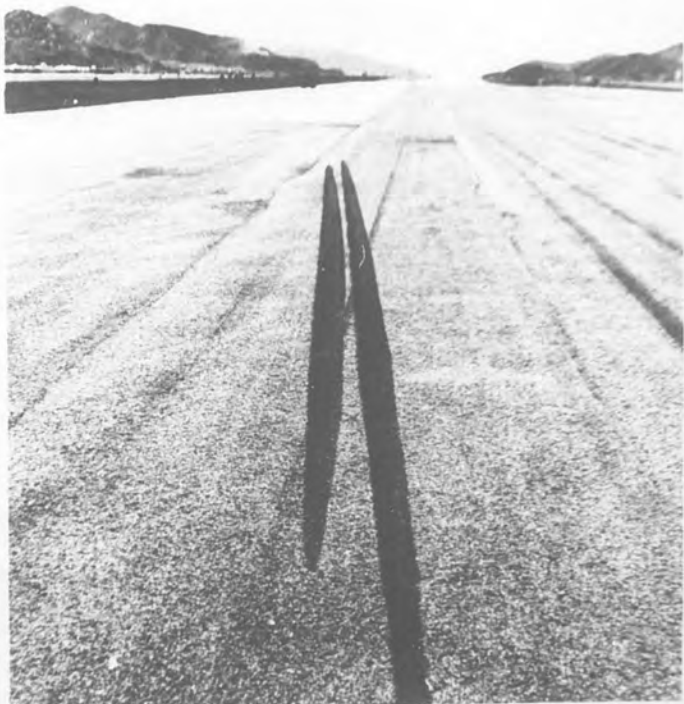
Enclosure 28

HEAVY SKID MARKS DEPICTING TORQUE PRESSURE BEING APPLIED TO NOSE GEAR.
Special Handling Required in accordance with Para 66 OTNAV INST 3750.6B

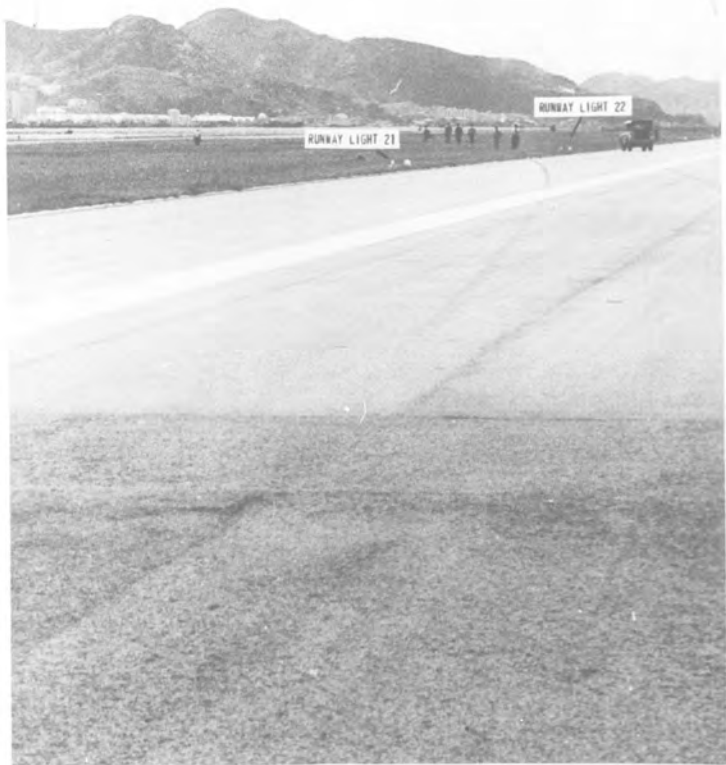
Enclosure 29

MAIN LANDING GEAR MARKS DEPICTS PATH OF AIRCRAFT AS AIRCRAFT LEFT RUNWAY.
NOSE GEAR OFF DECK. RUNWAY LIGHTS MISNUMBERED. SHOULD BE NUMBER 19 & 20.

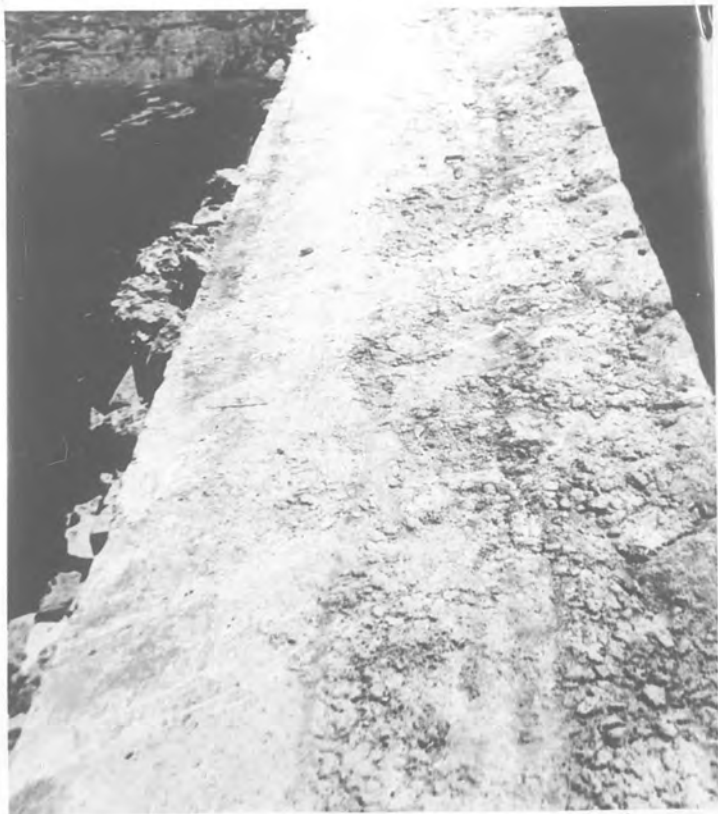
Enclosure (3)

SEAWALL WHERE LEFT WING TIP MADE INITIAL IMPACT (NOTE WHITE ANGULAR LINES)

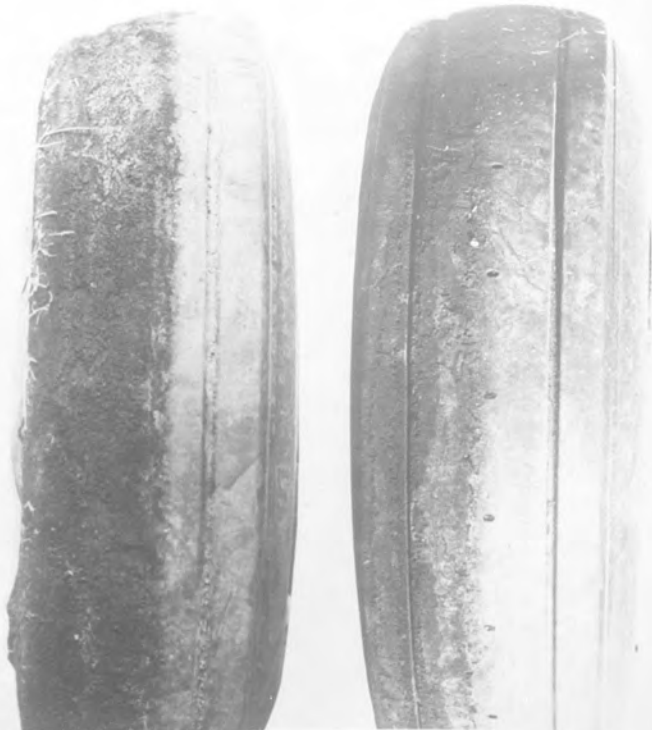
b. A contributing cause of this mishap is pilot factor on the part of co-pilot in that he failed to employ proper technique to maintain directional control during take off.

NOSE GEAR TIRES SHOWING EXCESSIVE WEAR INDICATING AMOUNT OF CORRECTION
REQUIRED TO MAINTAIN DIRECTIONAL CONTROL.
